Manhole Inspection Summary

Manhole # S13EE_005MH

Location Address: **2819 PRESSMAN ST**

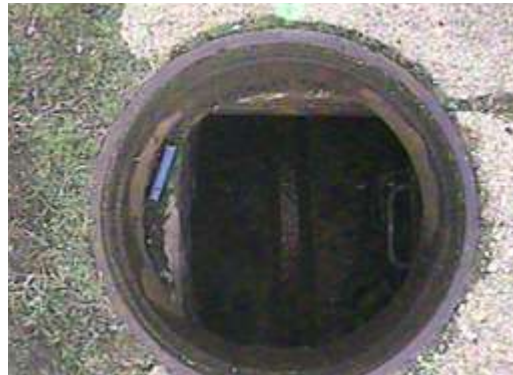
Top View

Frame Offset: **2** (in.) Condition: ☒ Sound ☐ Cracked ☐ Leaks

FRAME OFFSET

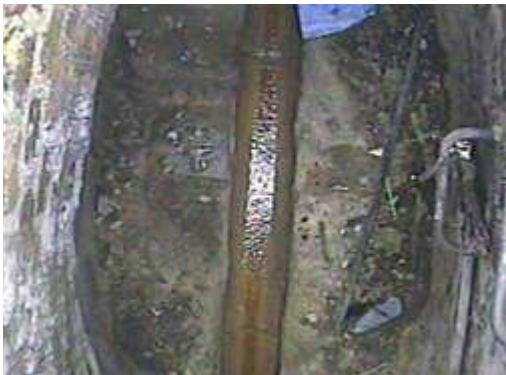
Top View

DEBRIS ON BENCH

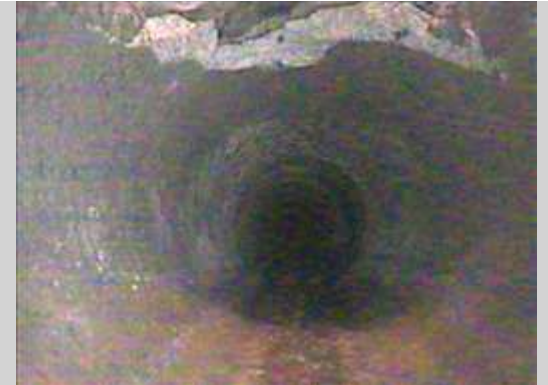
12 O'Clock Outflow

6 in. Circular Gravity Sewer
Pipe Out @ 12 O'Clock

Pipe Height: (in.) Direct
Pipe Material: **Clay** ☐ Pipe Lined
Invert Depth: **5.94** (ft.) Flow Characteristics: **Fast**
Deposits: ☒ None ☐ Mud ☐ Sludge ☐ Debris ☐ Grease
Silt Depth: (in.) Deposits Extent:
Infiltration: **None** Pipe Seal Cond: **Cracked**
